MSC-07230

NATIONAL AERONAUTICS AND SPACE ADMINISTRATION

APOLLO 16 MISSION REPORT

MANNED SPACECRAFT CENTER
HOUSTON, TEXAS
AUGUST 1972

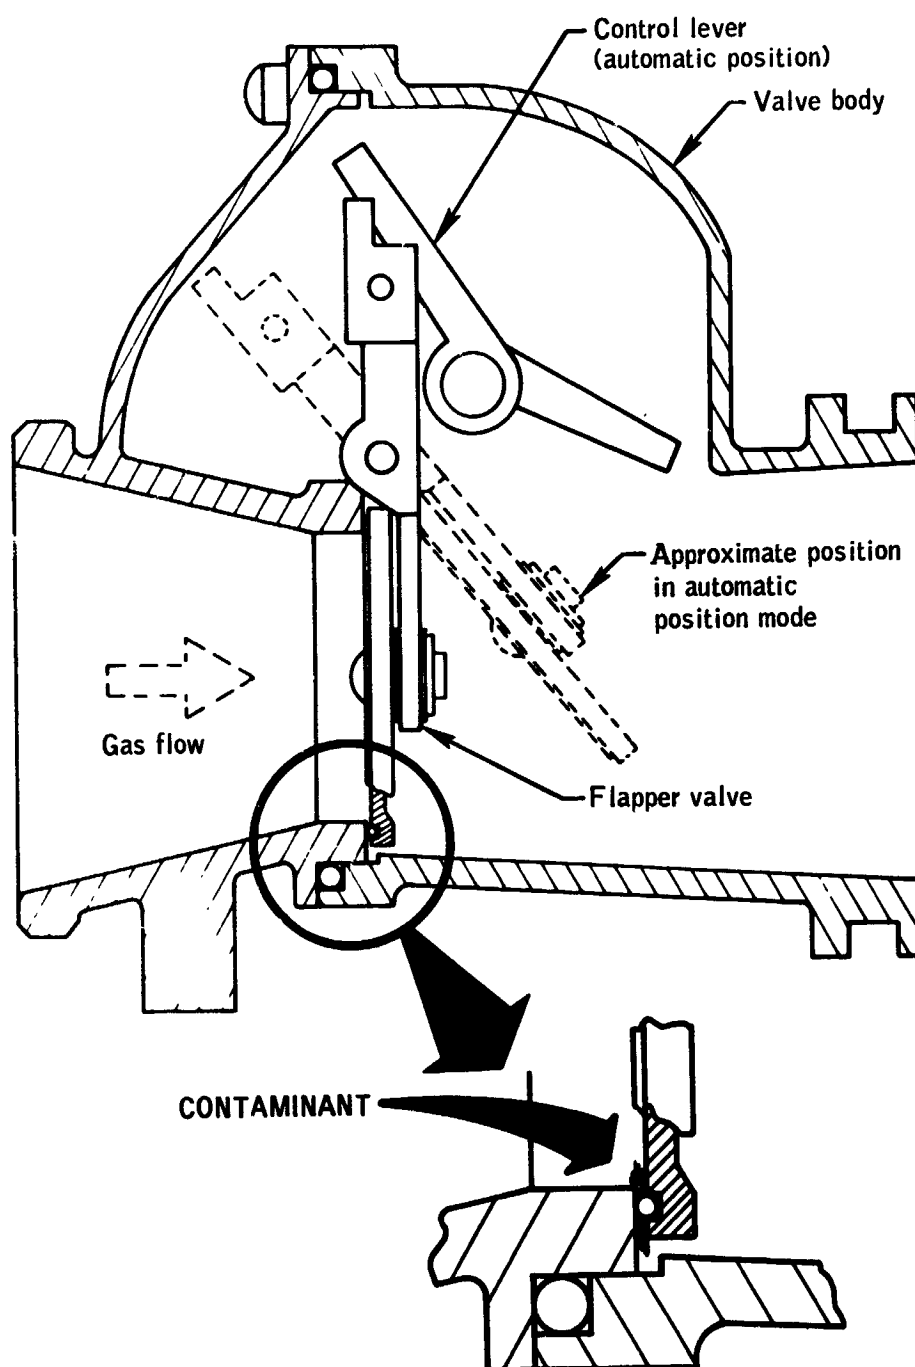
Figure 14-39.- Cabin gas return valve.

Since the valve functioned properly upon activation and again late in the lunar stay, the apparent cause of the problem was contamination. There are two possible areas of contamination: material on the inlet screen or residue on the flapper seal (fig. 14-39). A suspected source of residue is the orange juice that leaked from the drink bags.

A test will be performed on the Apollo 17 lunar module to check the force needed to open the cabin gas return valve flapper in the "automatic" position, thus increasing confidence in the ground checkout of the valve.

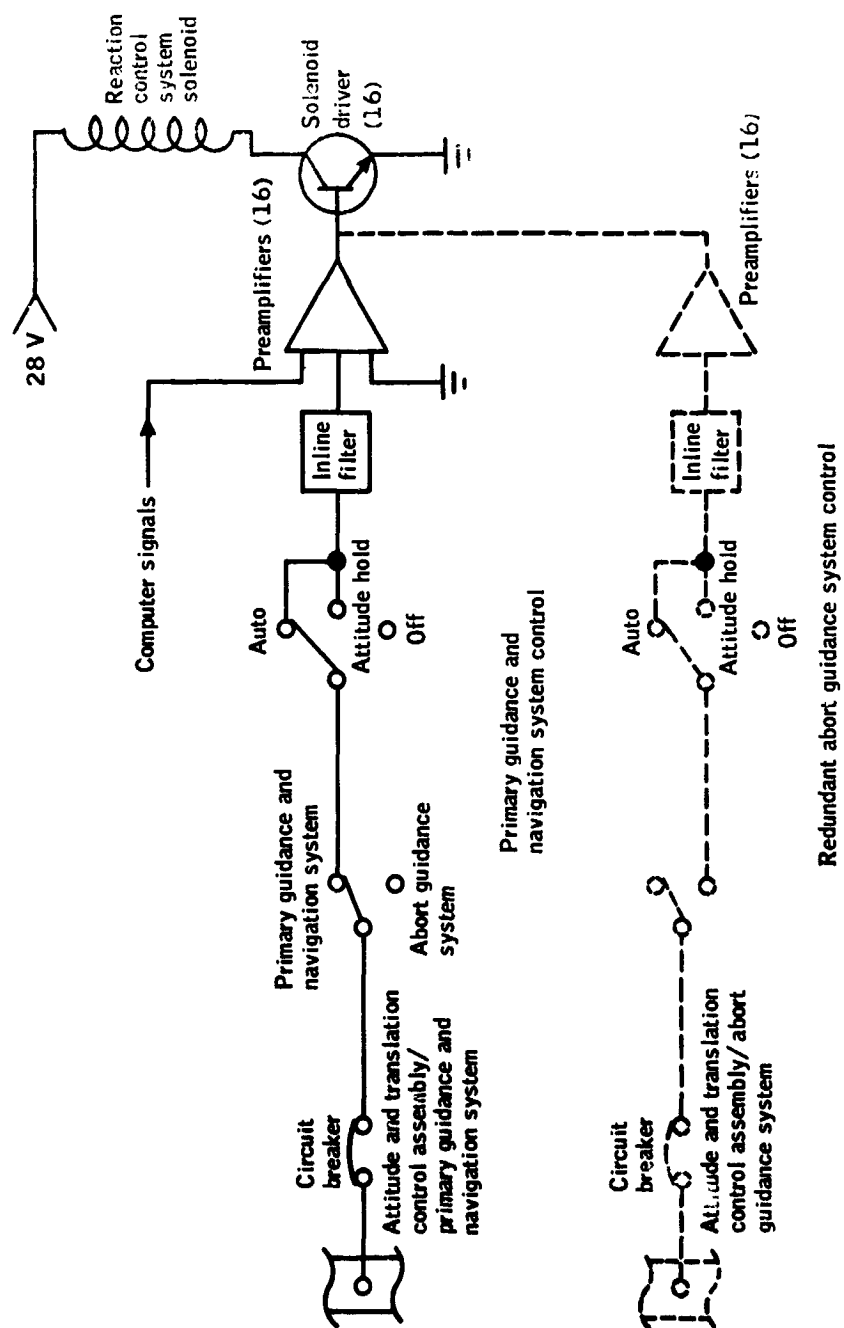
Figure 14-40.- Reaction control system control schematic.

Any of the following conditions could have caused the problem (refer to fig. 14-40):

Review of flight data and failure histories has been performed and the following conclusions reached:

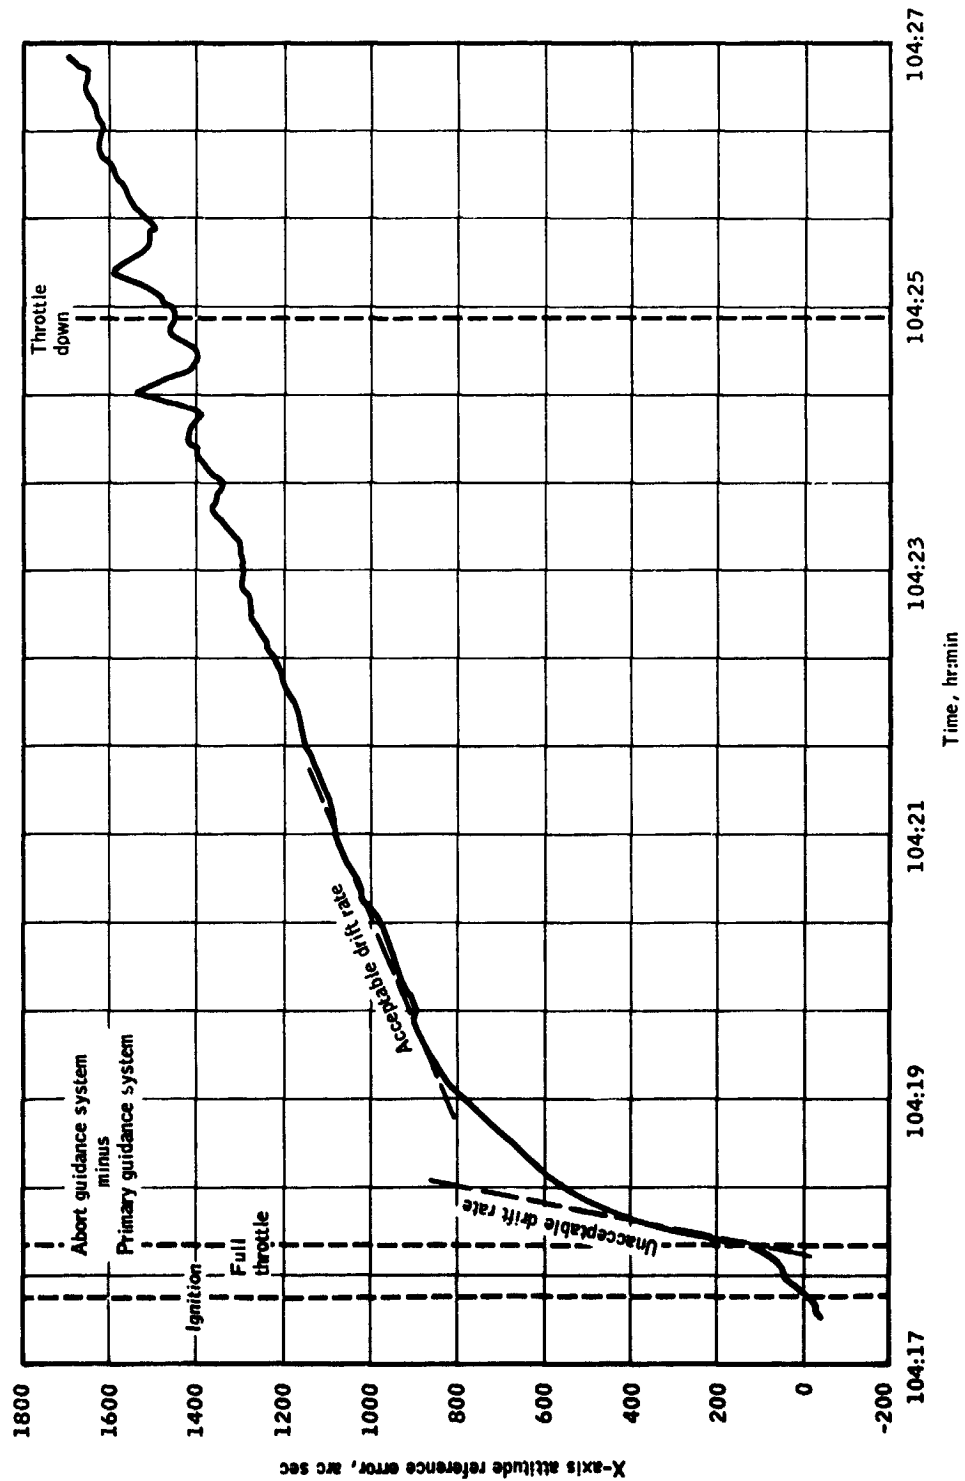
Figure 14-41.- Attitude reference error during descent.

Figure 14-41 is a time history of the difference between the abort guidance system and the primary guidance system X-axis attitude reference during descent. The rapid error buildup during the first 2 minutes indicates drift rates of up to 19 degrees per hour. No reason can be given for these high drift rates; however, a change in the X-axis gyro performance characteristics obviously took place. The steady drift rate of 2 degrees per hour during the last 8 minutes is believed to have been caused by a shift in a mass unbalance along the X gyro spin reference axis. Drift caused by this mass unbalance was also apparent in the data for the lunar surface calibration (due to gravity) and during ascent (due to the ascent engine thrust).

The roll axis misalignment is accounted for by the higher-than-normal drift rates during descent.

No indication of a problem existed before launch. Hardware malfunctions of the gyro and associated electronics have been hypothesized in an attempt to construct a model which would reproduce the error curve shown in figure 14-41. The worst-case electronics failure would only produce drift rates of 1 degree per hour compared to the 19 degrees per hour observed. Mechanical failures within the gyro which would duplicate flight results have a very low probability of occurrence. Therefore, the most likely cause is contamination or an air bubble in the fluid between the gyro float and case.

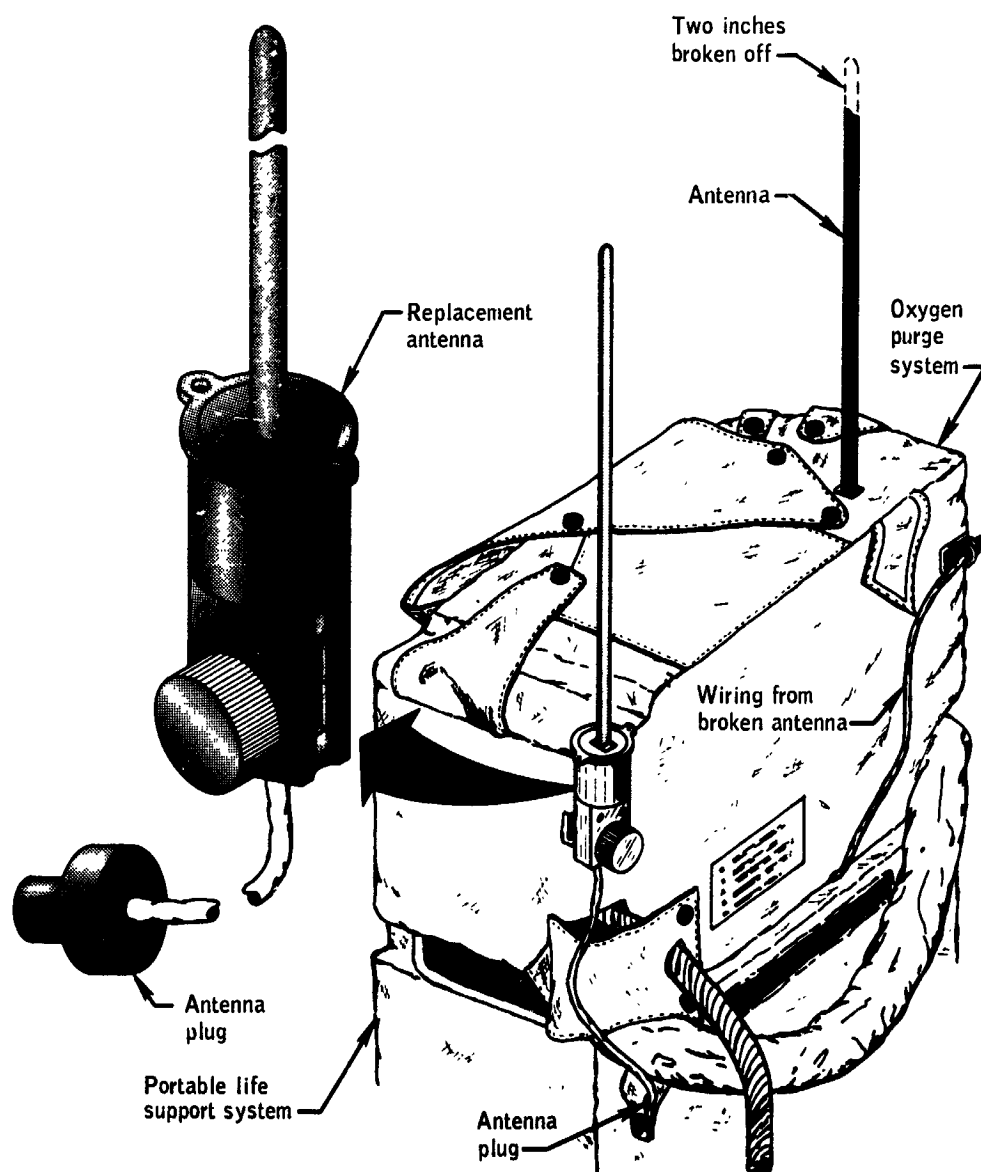
Figure 14-43.- Oxygen purge system antenna.

Following ingress after the second extravehicular activity, the crew reported that approximately 2 inches had been broken off the tip of the antenna on the Commander's oxygen purge system (fig. 14-43). The antenna had inadvertently been left unstowed while ingressing and it is believed that the antenna was broken when it struck the ascent propulsion system engine cover as the Commander was entering through the hatch.

One spare oxygen purge system antenna will be carried on Apollo 17 and will be stowed in the buddy secondary life support system bag on the lunar roving vehicle.

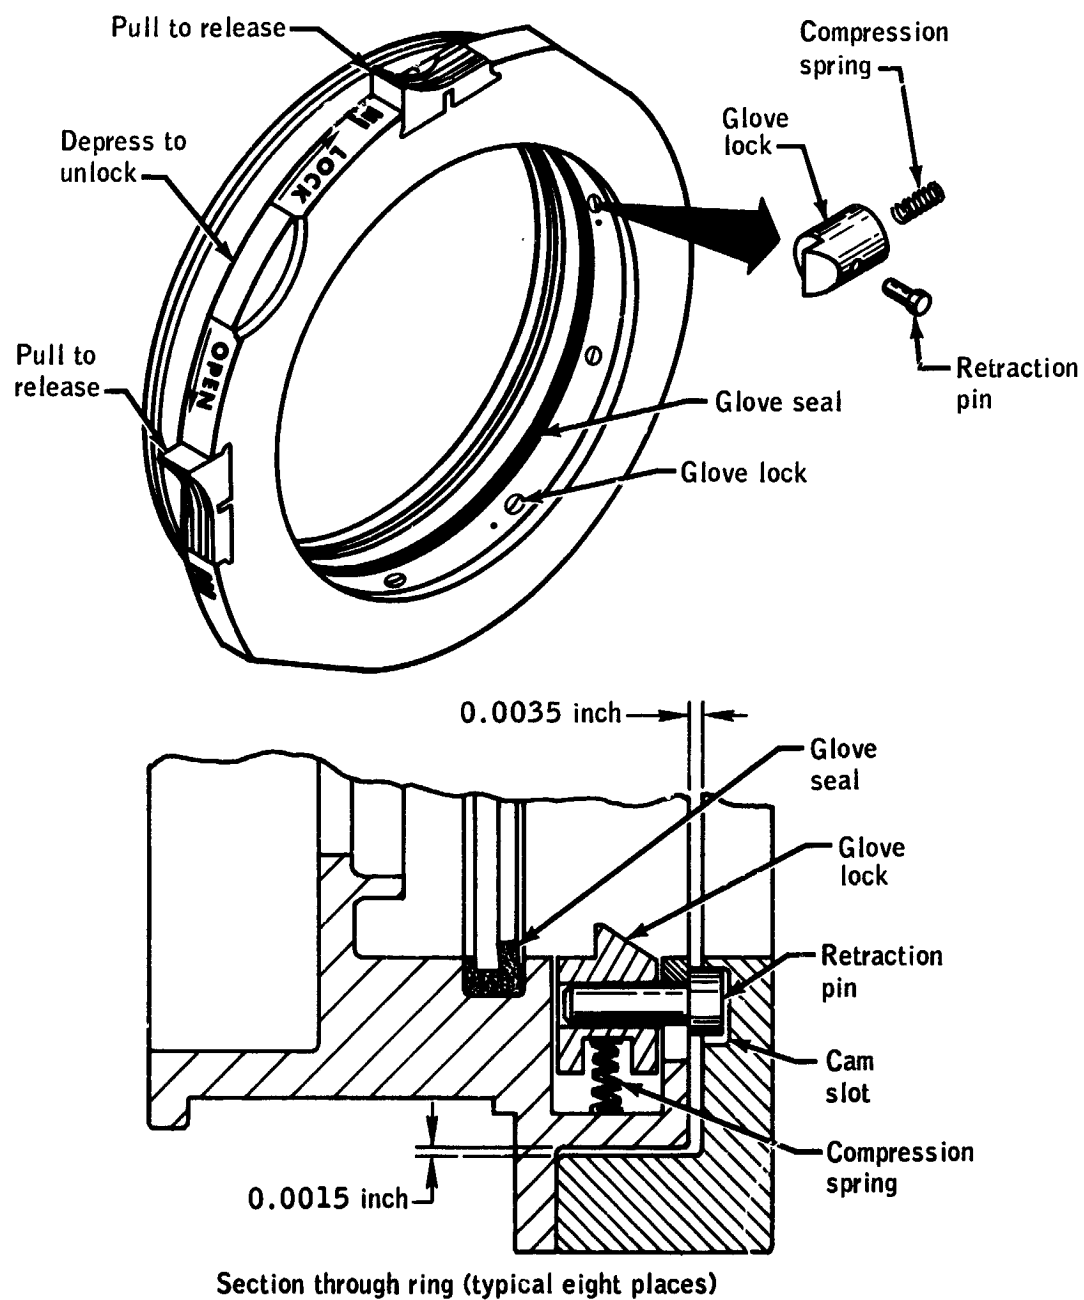
Figure 14-45.- Wrist disconnect.

After exposure to the lunar surface environment, the wrist ring disconnects on the Commander's and the Lunar Module Pilot's suits were hard to rotate to the locked position and, once locked, were very difficult to rotate out of the locked position. Lunar soil contamination is suspected as the causes of this problem.

The wrist disconnect attaches the glove to the suit sleeve (fig. 14-45) and is covered by a gauntlet on the glove. The gauntlet is loose fitting around the suit sleeve and dirt can get to the wrist disconnect. Small tolerances between the sliding surfaces are inherent in the design to make it impossible to accidentally unlock the wrist disconnects.

Postflight inspection of the wrist disconnects showed that lunar dust in the clearance areas caused the problem. Rubber dust covers for the ring disconnects which will afford better protection from contamination will be added for Apollo 17.

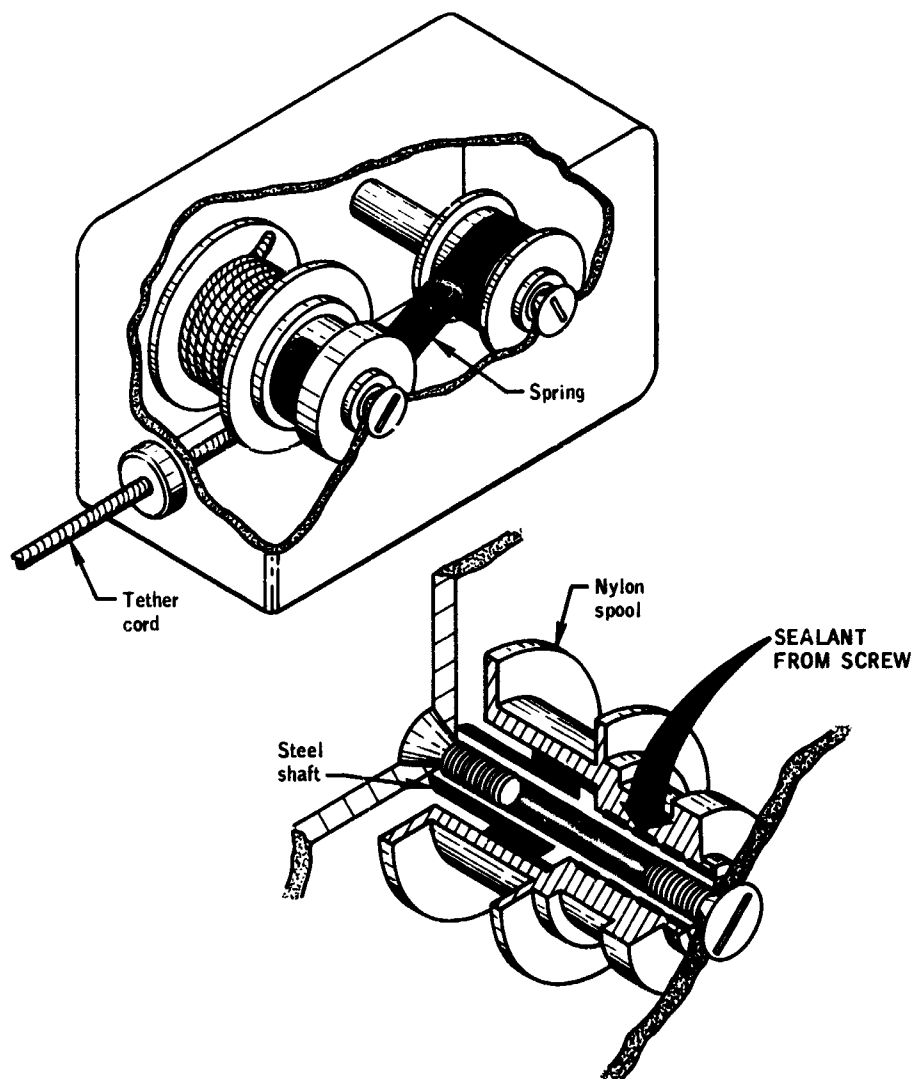
Figure 14-48.- Retractable tether.

Postflight inspection indicates that the tether is now operating; however, there is a noticeable increase in friction (fig. 14-48) during the retraction cycle. A thread sealant (loctite) was found on the spool shaft, which increased the friction.

Future units will be tested for friction buildup prior to flight.

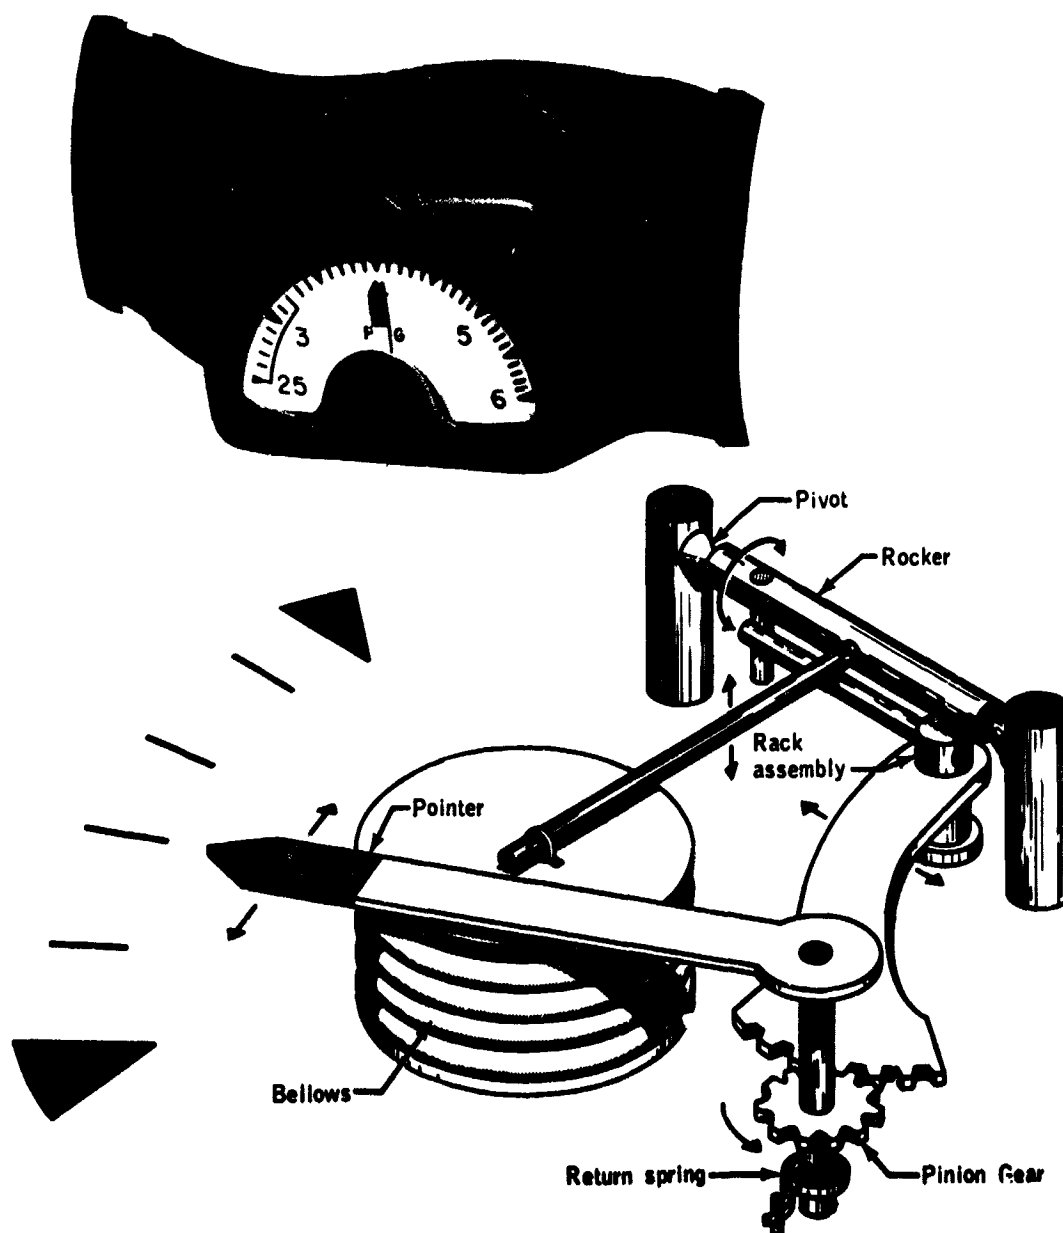
Figure 14-49.- Cuff gage mechanism.

During postflight testing at ambient and vacuum conditions, both the Commander's and the Lunar Module Pilot's gages read well within 0.1 psi of the 4.0 psi to which they were pressurized.

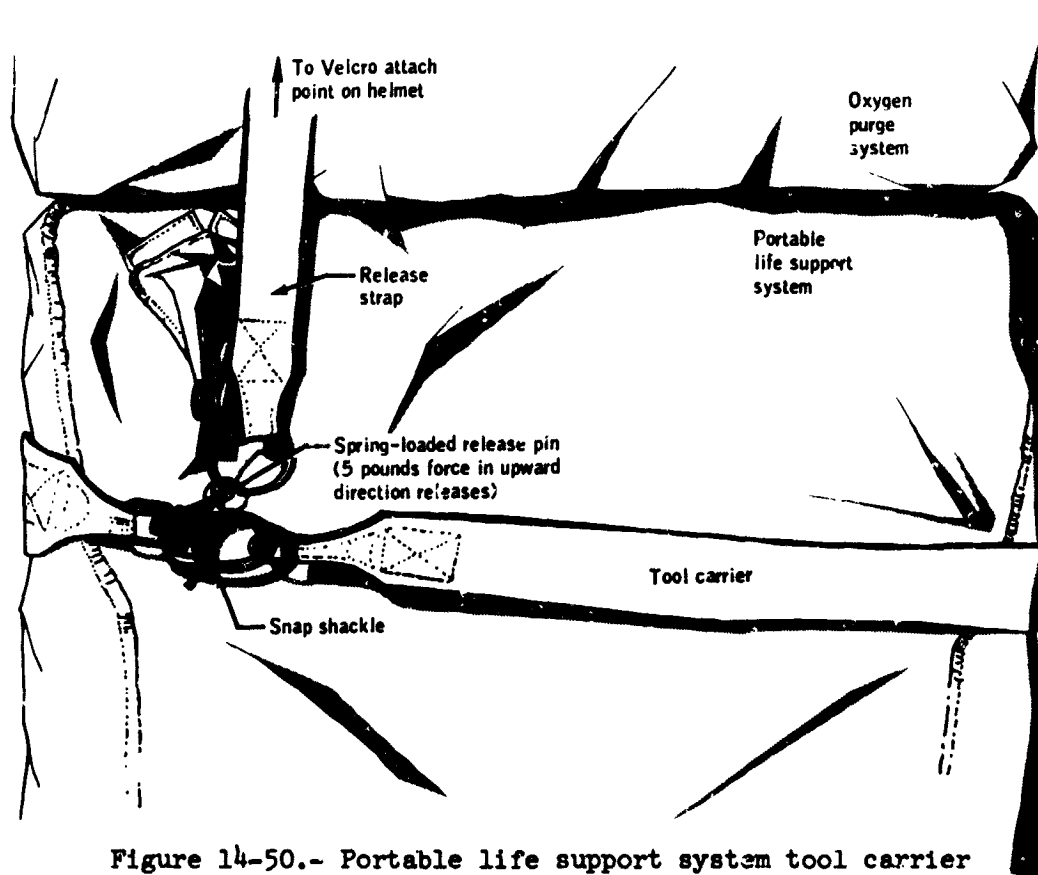
Figure 14-50.- Portable life support system tool carrier spring-pin shackle connection.

The harness is held together by a quick-disconnect snap buckle which has a spring-loaded release pin (fig. 14-50). Only a small force (5 lb) on the release strap is required to move the pin. The pin was inadvertently pulled during the cabin activity.

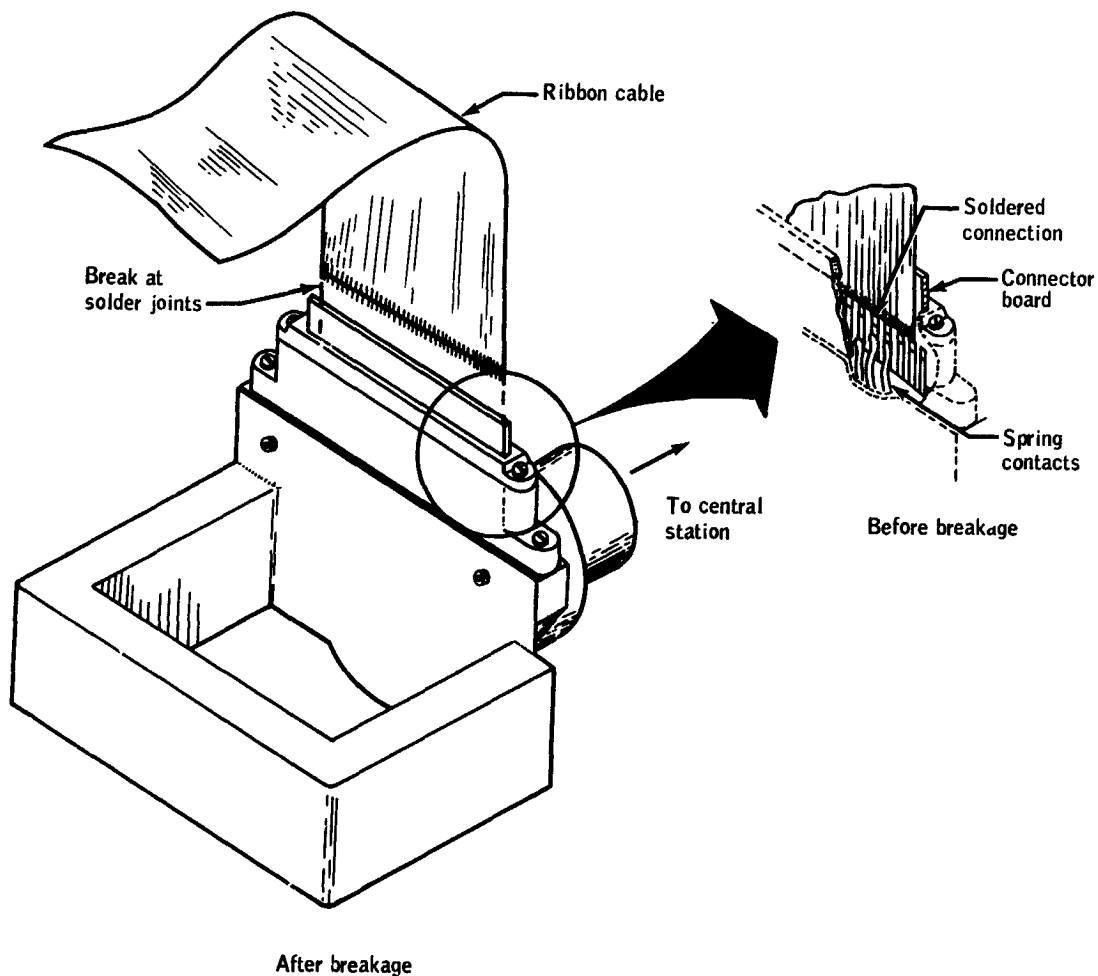
Figure 14-51.- Heat flow experiment connector.

The heat flow experiment is stowed on subpackage 2. Upon arrival at the Apollo lunar surface experiments package deployment site, the experiment is removed from the subpackage and the electrical ribbon cable is connected to the central station by an Astromate connector (fig. 14-51). The cable is bonded and soldered to a printed circuit board which is clamped in a connector. The cable-to-board joint is reinforced by two to four thicknesses of 0.5-mil Kapton tape.

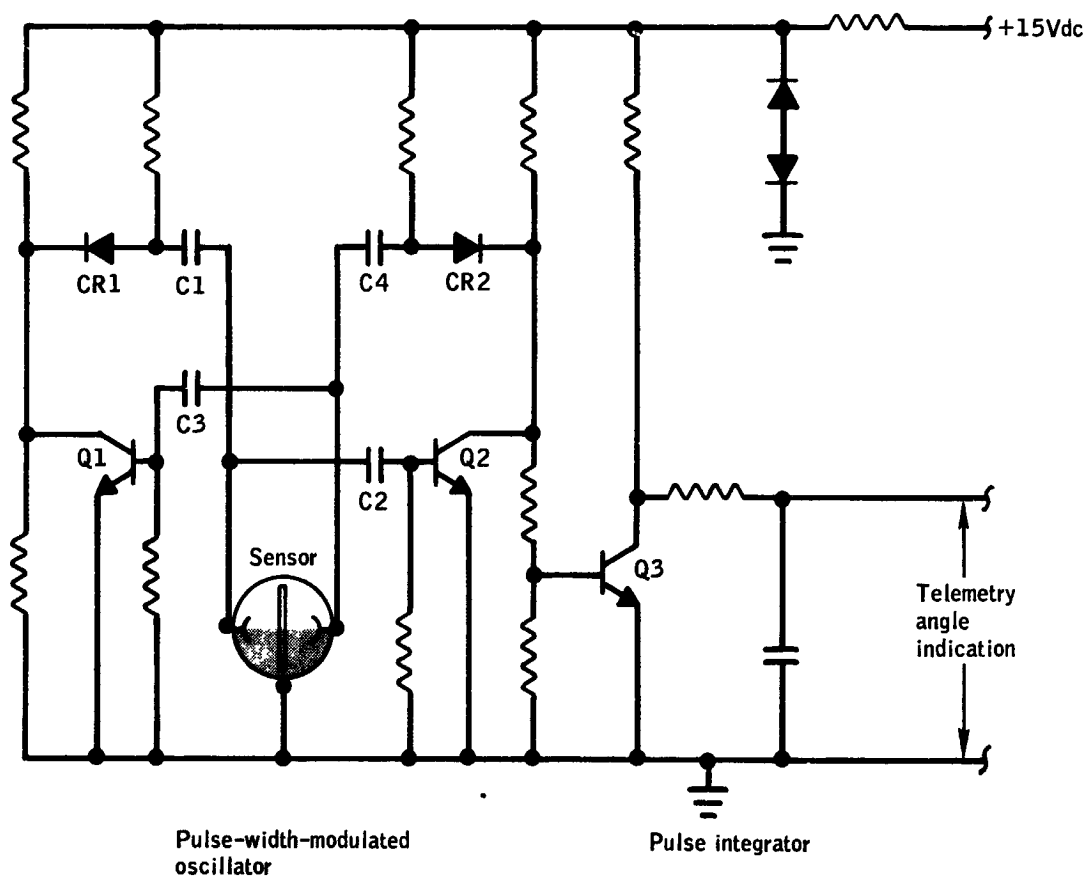
Figure 14-54.- Roll or pitch angle sensor electronics.

The sensor circuitry includes a free-running multivibrator, with the pulse-width ratio controlled by the sensor which functions as a potentiometer (fig. 14-54). Numerous failure possibilities in the circuit, such as open transistors, shorted capacitors, and open solder joints could have caused failure of the multivibrator and the off-scale high reading.

Note: An open in any component in the pulse-width-modulated oscillator (CR1, CR2, C1, C2, C3, C4, Q1 and Q2) is a single-point failure, or an open in the pulse integrator (Q3) is a single-point failure.

No corrective action is required as the experiment is not scheduled for another mission.

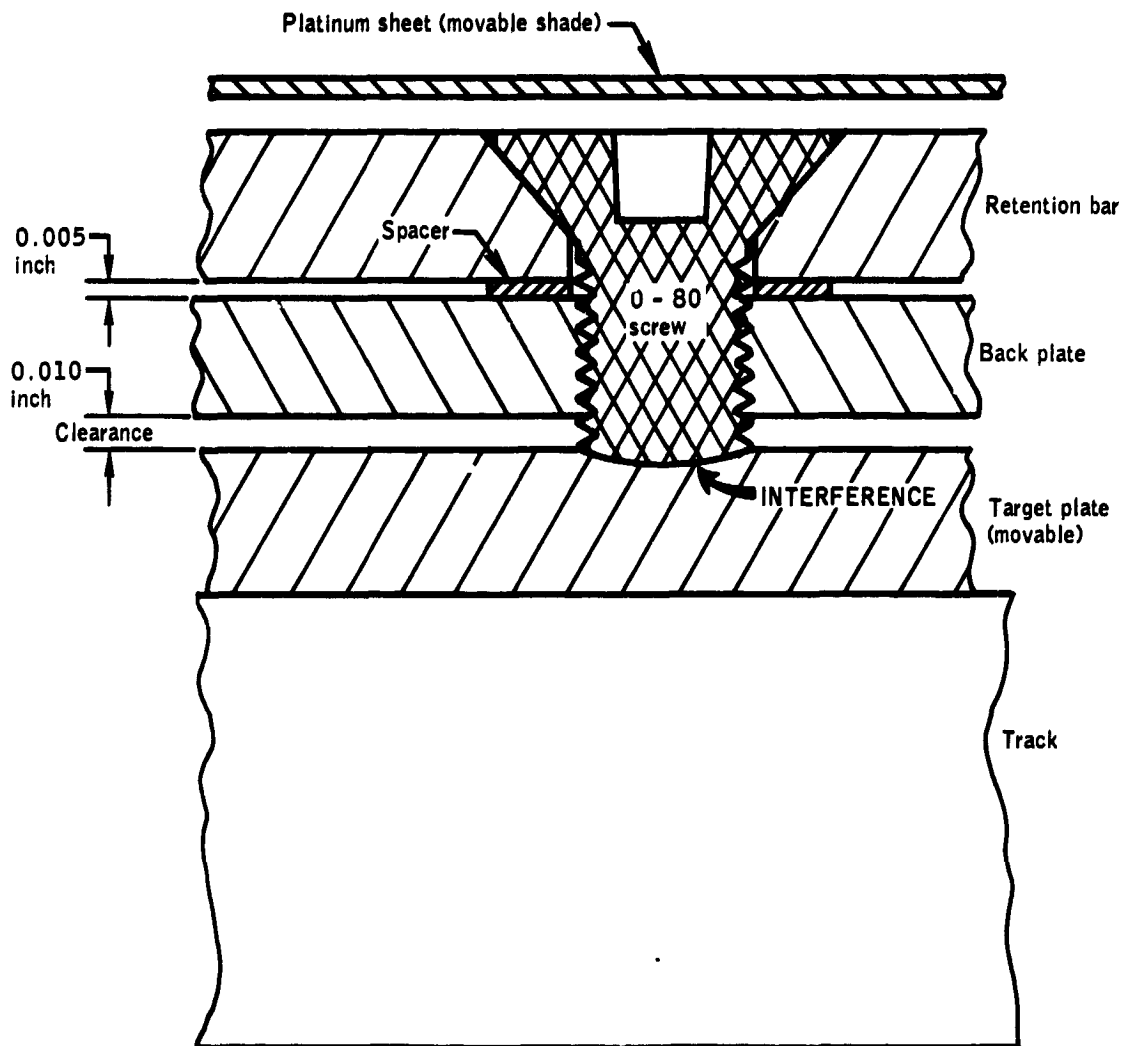
Figure 14-57.- Panel 4 screw interference

Examination of the panel assembly has shown that the failure of the shifting mechanism was caused by a clamping of the target plate by two retention bar screws which projected past the backplate into the target plate, and effectively locked it in place (fig. 14-57).

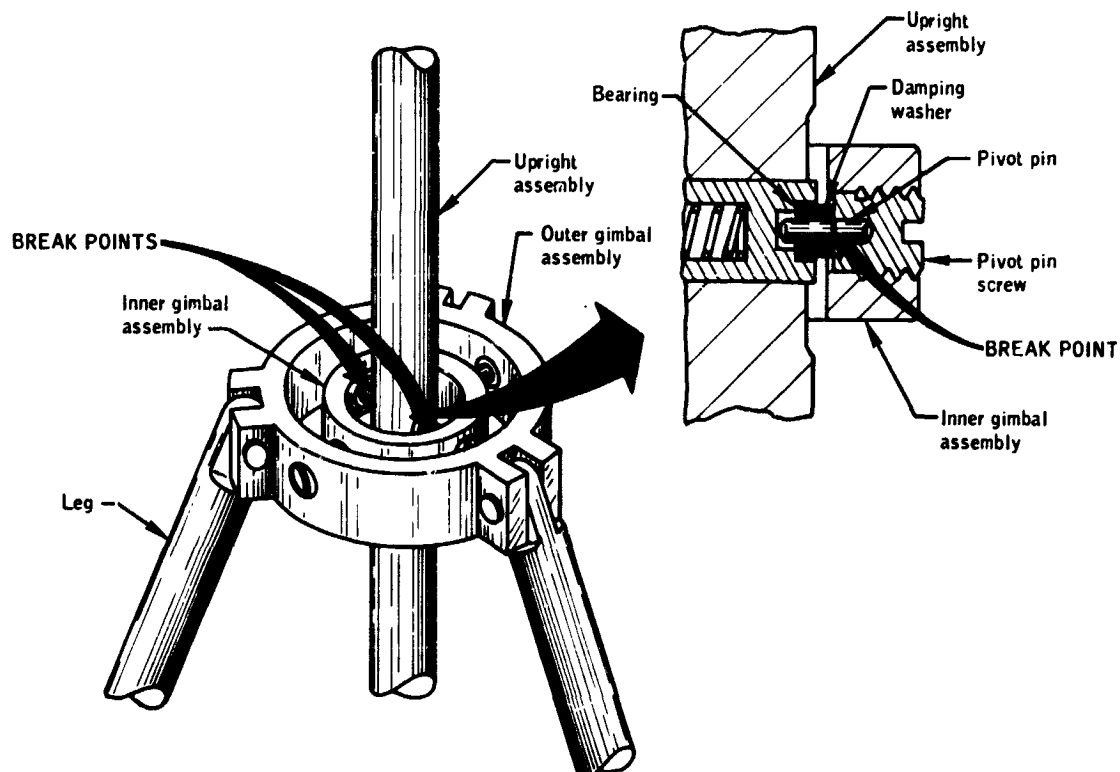
Figure 14-59.- Gnomon gimbal assembly

The staff can be separated from the leg assembly by backing out the gimbal pivot screws. However, all four screws must be backed out (fig. 14-59). There was no indication in the photographs of any screws backing out. During ground operations, a staff separated from the leg assembly by breaking the inner gimbal pivot pins. The break occurred where the 0.040-inch-diameter pivot pin is pressed into the pivot screw.

The pivot assembly consists of standard high-speed steel reamer blank material pressed into a stainless steel adjusting screw or retainer. The reamer blank material provides the high strength and hardness required,

but has a tendency to be brittle without additional tempering. In addition, the combination with stainless steel can be conducive to stress corrosion. Either, or a combination, of the two conditions is considered as the most likely cause of the anomaly.

Pivot pins for the Apollo 17 gnomon will be given the additional tempering required for greater toughness, and a thin film of oil will be applied for protection against corrosion. Ground tests have shown the

damping will be unaffected. Assembly of the pin in the screw will be delayed until as late as possible before launch so as to reduce the time for possible stress corrosion to occur.

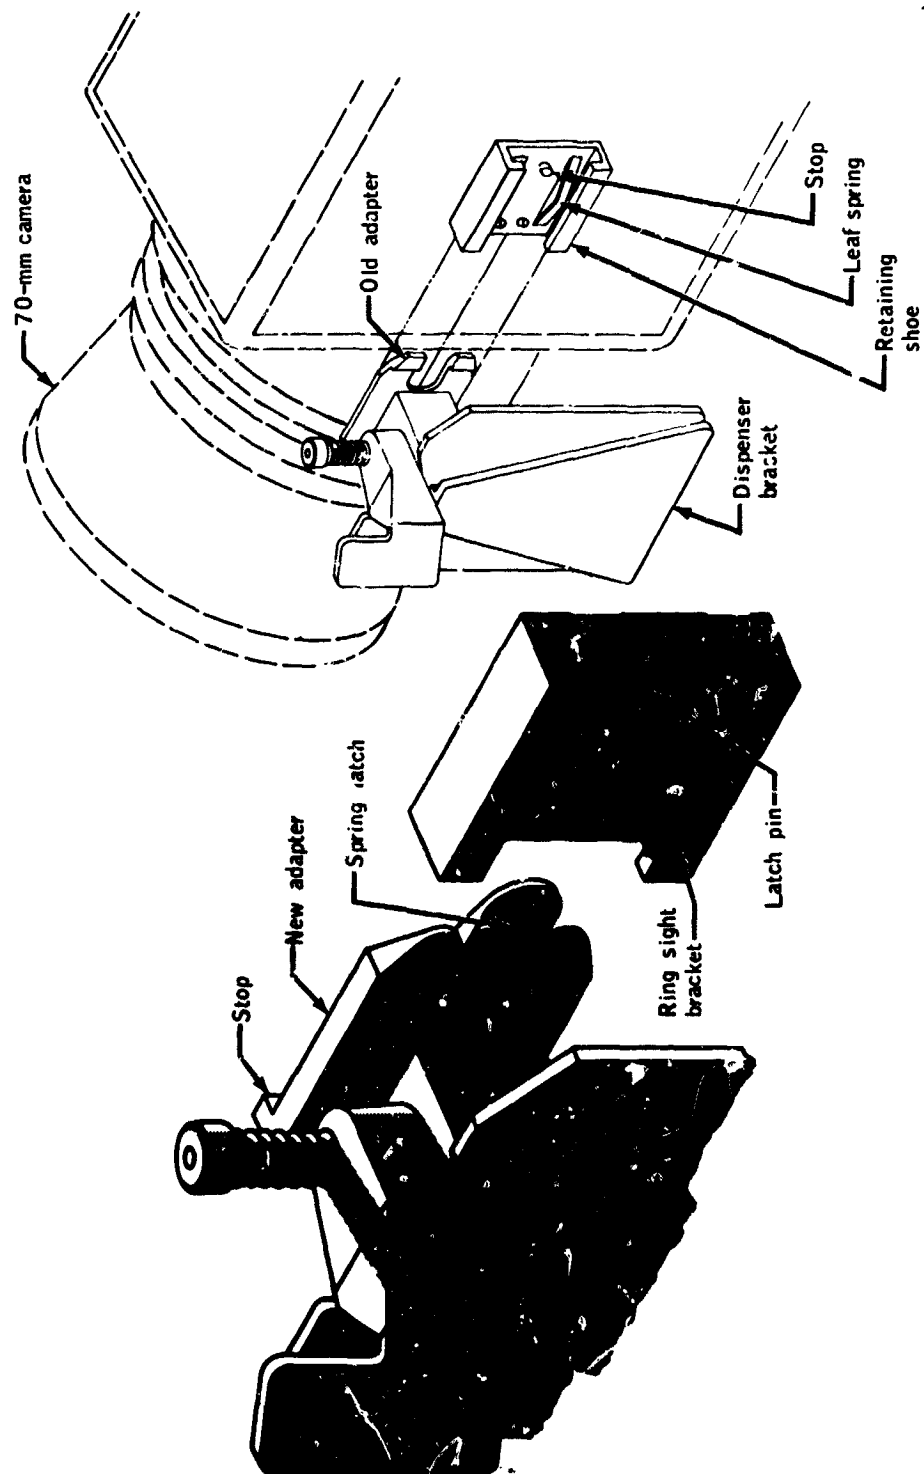
Figure 14-60.- Sample bag dispenser retention.

The dispenser is mounted on an adapter (fig. 14-60) which is inserted in the ring-sight tee-slot bracket on the camera. The adapter-to-tee slot interface is horizontal and depends on springs in the tee slot to hold the adapter in the latched position. This latching method is inadequate.

The adapter has been redesigned so as to provide a positive lock in the installed position as shown in figure 14-60.

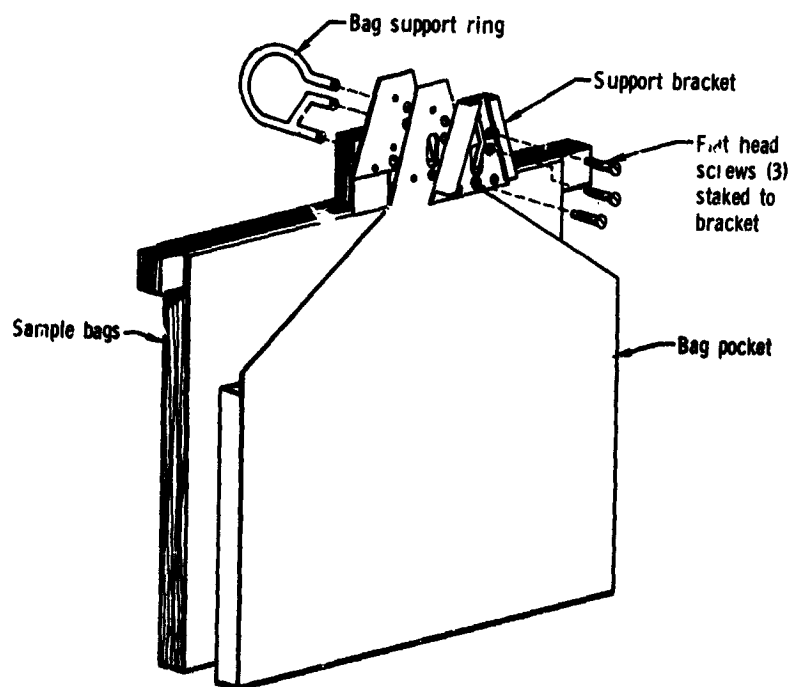
Figure 14-61.- Documented sample bag dispenser assembly.

The three flat-headed stainless steel screws mate with threads in the aluminum ring (fig. 14-61). The heads are staked to the aluminum bracket plate. Thread sealant materials are not permitted because of the possibility of lunar sample contamination.

The Apollo 17 dispensers will be re-inspected to assure proper staking of the screws and tightness of the threads in the aluminum ring.

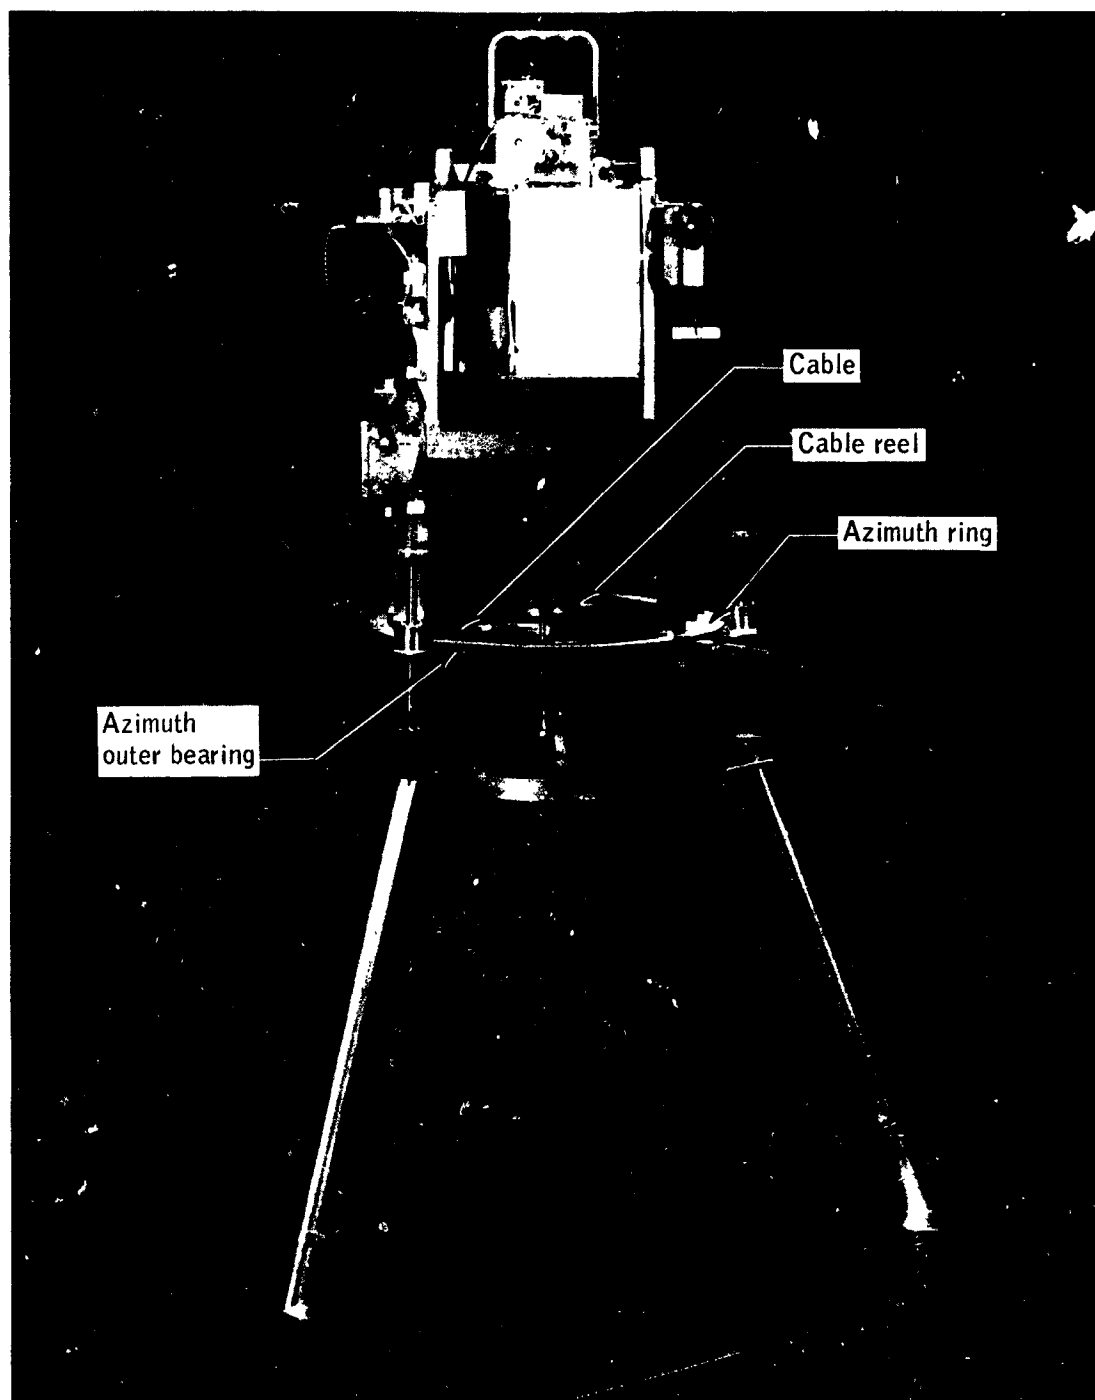
Figure 14-63.- Far ultraviolet camera.

To adjust the azimuth to the proper dial reading, the camera is rotated on a 12.5-inch diameter ball-bearing ring (fig. 14-63). The bearing is not sealed; however, the crew did not observe any lunar dust on the bearing.

The azimuth ring bearing was packed with a waxy, low-outgassing grease which stiffens appreciably at temperature below 50° F. This grease is normally used as a sealant rather than a lubricant. The camera was intentionally kept in the shade to protect the film from high temperatures. As a result, the grease stiffened. The manual azimuth adjustment operation was not included in cold chamber tests with other operations of the camera.

The difficulty was caused by the use of the wrong type of grease in the azimuth ring bearing.

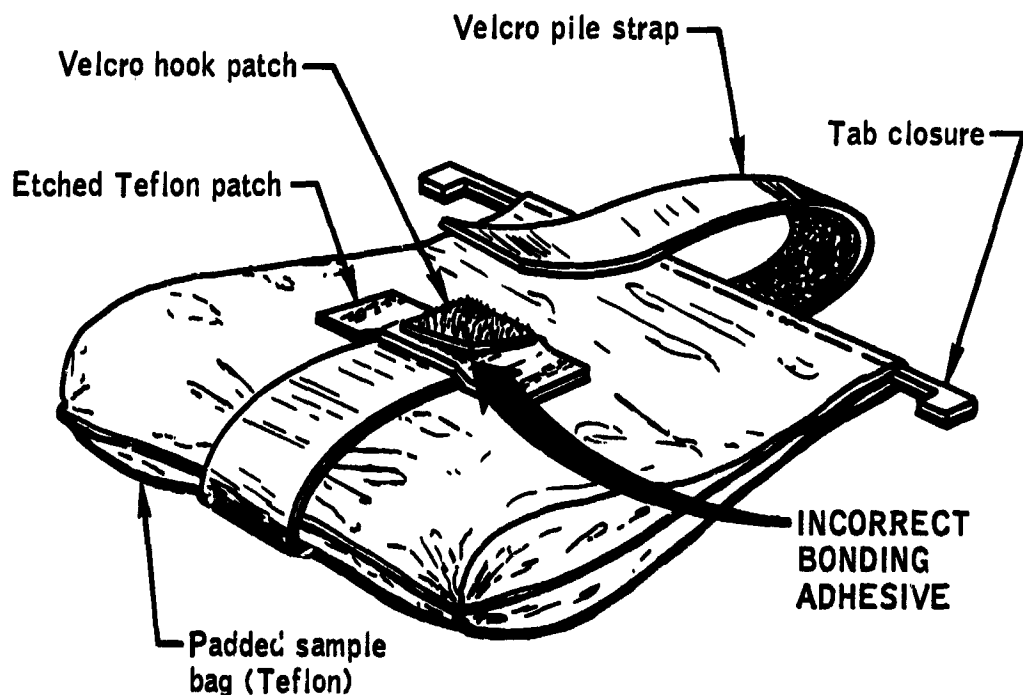
Figure 14-64.- Padded sample bag.

When the crew wrapped the Velcro strap around each of the padded sample bags to further secure them, the Velcro attachment patches came off the bags and the straps were ineffective.

A 20-inch-long wrap-around Velcro pile strap is provided to hold the bag closed in addition to the usual tab closure (fig. 14-64). One end of the strap is bonded with a fluorel adhesive to an etched Teflon patch which

is heat-sealed to the Teflon bag. A Velcro hook patch is bonded to the etched Teflon patch with a pressure-sensitive adhesive and provides the attach point for the other end of the strap. The peel strength of the pressure-sensitive bond was less than that of the Velcro pile-to-hook connections. Consequently, when the Velcro strap was adjusted to the proper tension, the hook patch came off the bag.

The problem resulted from using the improper bond material for the Velcro hook patch.

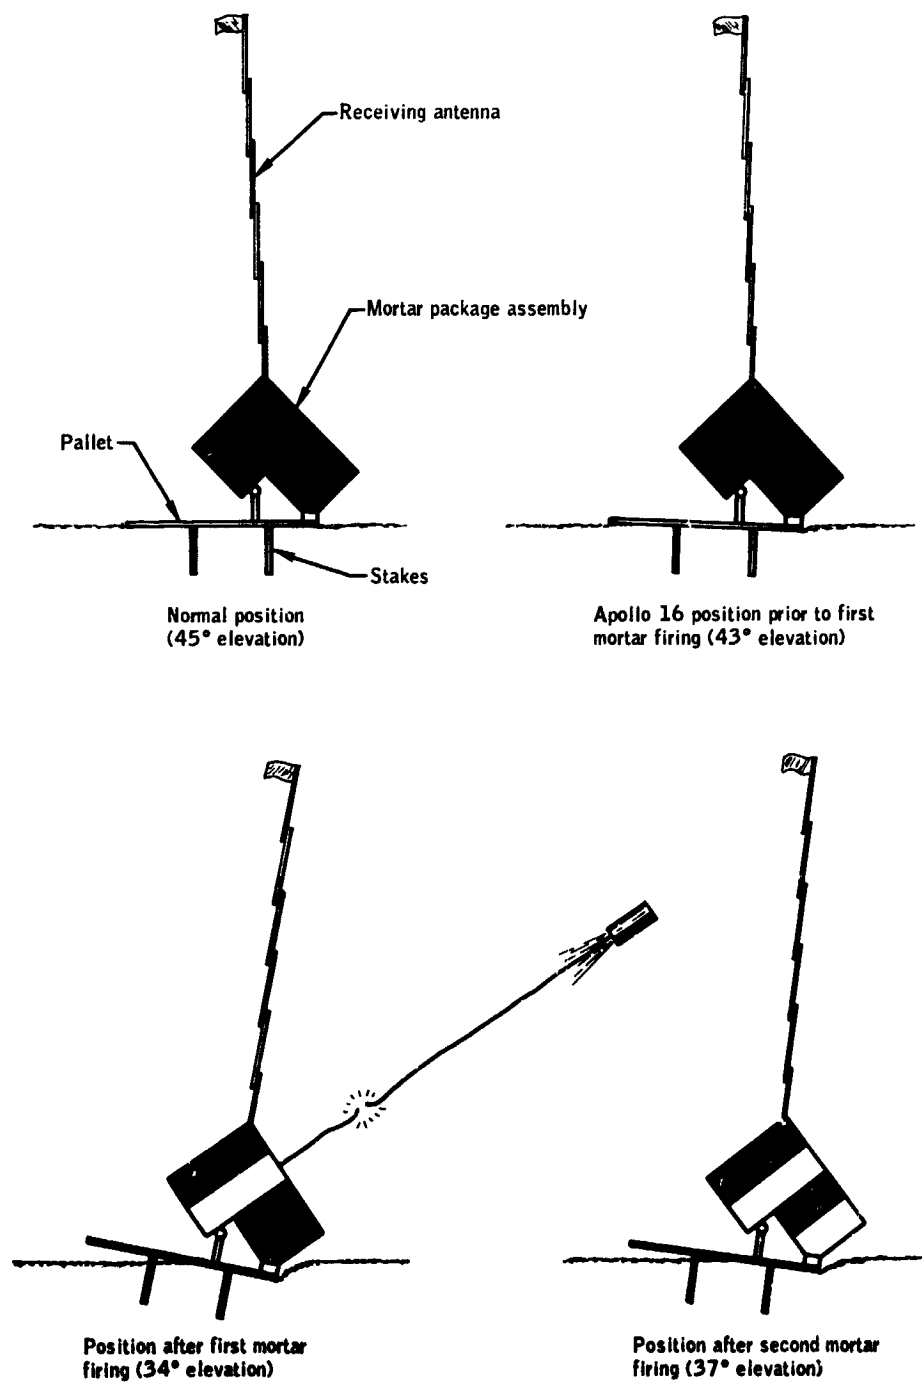
Figure 14-65.- Pitch movement of mortar package assembly.

Immediately prior to launching the third grenade, the pitch sensor indicated that the mortar package assembly was pitched down about 8° from the nominal plus 45° elevation (fig. 14-65). Within 2 seconds after firing the mortar, the sensor indication was off-scale-high and has remained off-scale-high.

Based on ground tests during which the assembly was rotated through 360°, an off-scale-high indication means either that the mortar package assembly is pitched up between 25° and 155° above the normal plus 45° elevation, or that the sensor has failed. There are two stable positions of the mortar package and pallet assembly between these two points: (1) pitched up 30° above normal (75° elevation), and (2) pitched up 135° above normal (180° elevation). The temperature profiles for the two temperature sensors on the mortar package assembly, when compared with the calculated temperature profiles for elevations of 45° and 75°, indicated that the mortar package assembly was not in the 75° elevation position. In the 180° elevation position, the receiving antenna would have been broken off or badly bent and lying on the ground. In this case, complete real-time event data would not have been received during the flight of the third grenade. However, complete real-time event data were received during the entire 19-second flight, indicating that the mortar package assembly was not in the 180° elevation position.

The pitch and roll sensor circuits are identical (sec. 14.4.3), and there are numerous failure possibilities in the circuit (such as open transistors, shorted capacitors, and open solder joints) which can cause failure of the multivibrator, and result in the off-scale-high indication.

It is most likely that there is a failure in the pitch sensor circuit, and the orientation of the mortar package is unknown.
